# A Case Study of Black Spot on Jaipur Kishangarh Section on National Highway - 48 in Rajasthan

Considering time availability. I have to limit my work on finding the issues pertaining to the redesigning of selected intersections and recommending measures for increasing the safety aspect of the project road. This paper presents a detailed study of safety audit at intersection near Bhankrota (Km 278.250 to 278.550).

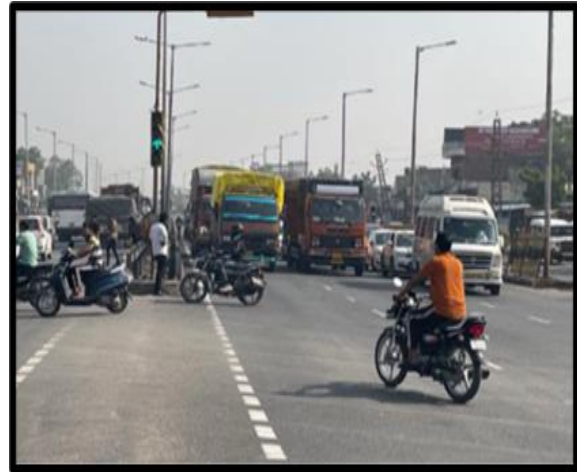
- This is a three-legged intersection located on Six laned carriageway with service road in both sides.
- Accidents data revealed that most of accidents was occurred due to overspeed of vehicles approaching the intersection.

- In absence of refuge island, it was difficult for pedestrians to cross over the road.
- The turning radius is not sufficient causing difficulties for traffic movement towards the road leading to Jaisinghpura village.

- Although the intersection is signalized but it is observed that road commuter often jumping the signal.
- There is lack of necessary road signages at intersection location.

- From past three years accident trends shows that accident occurred at the junction is due to lack of proper pedestrian facility, wrong parking of Vehicles in front of Shops, obstruction of sight distance and over speeding of two-wheeler.

main carriageway are damages at many locations in both sides resulting reckless movements of pedestrian and two-wheeler.

- There is no provision of authorized parking near intersection encouraging haphazard unregulated on- street parking, which is likely to affect the capacity and safety of the intersection.
- The opening/access of the side road leading to Jaisinghpura village is very near to junction causing increased the number of conflicts.

Fig. 4 Actual site view of Bhankrota Intersection

- Speed of vehicles approaching the intersection need to be reduced by providing Transvers Bar marking (TBM) on major carriageways of NH-

- 48 as per IRC: 35 -2015 and also provide rumble strips as per IRC:99-2018.
- There are encroachments observed on RHS service Road. The same need to be removed for safe movement of traffic

- Road marking as per IRC 35:2015 need to be done to instruct the drivers about the road. while doing audit road marking work has been made. Pedestrian crossing marking as shown in base plan need to be marked. Road studs (cat eyes) need also to be placed.

- Pedestrian crosswalks at mid blocks could be designed at an angle than being at 180 degrees straight angle. Providing crosswalks at an angle would promote better visibility to both the pedestrian as well the coming vehicle.

- Refuge islands need to be provided to enhance safety of pedestrian as per IRC:103-2012. This will give facility of local commuter to cross the main carriageway of NH-48 and approach road leading to Jaisinghpurs.village

- To caution drivers about the black spot location various signs are required to be placed as per IRC 67:2012 on both on main carriage of NH-48 and approaching road leading to Jaysinghpura village

- Solar Blinkers at starting of black spot on both direction (LHS & RHS) need to be placed to make driver aware that blackspot is about to start.

- Provided marked parallel parking bays along the road wherever possible to discourage unregulated and haphazard on-street parking.
- Replacement of Fixed Time traffic control signals/Flashing Amber with vehicle actuated signals to improve the safety as well as capacity of the junction during odd (off-peak) hours. Traffic signals are provided with primary, secondary, cantilever signal heads to be visible enough to be seen by all drivers and provided with pedestrian phases in the signal.
- The approach road leading to Jaisinghpura village need to be realigned brought nearly perpendicular to enhance the visibility of approaching side road traffic.

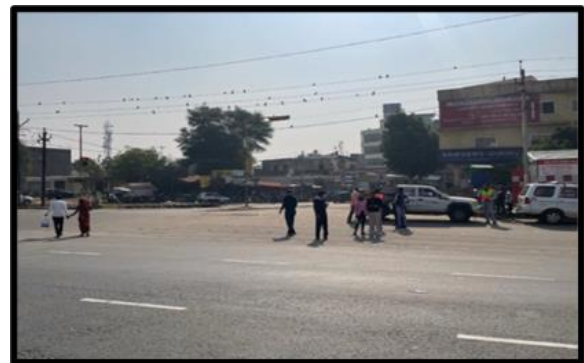
Fig. 5 Actual site view of Bhankrota Intersection
